Alternative Shoreline Stabilization Evaluation Project

Final Report

September 15, 2006

Prepared For:

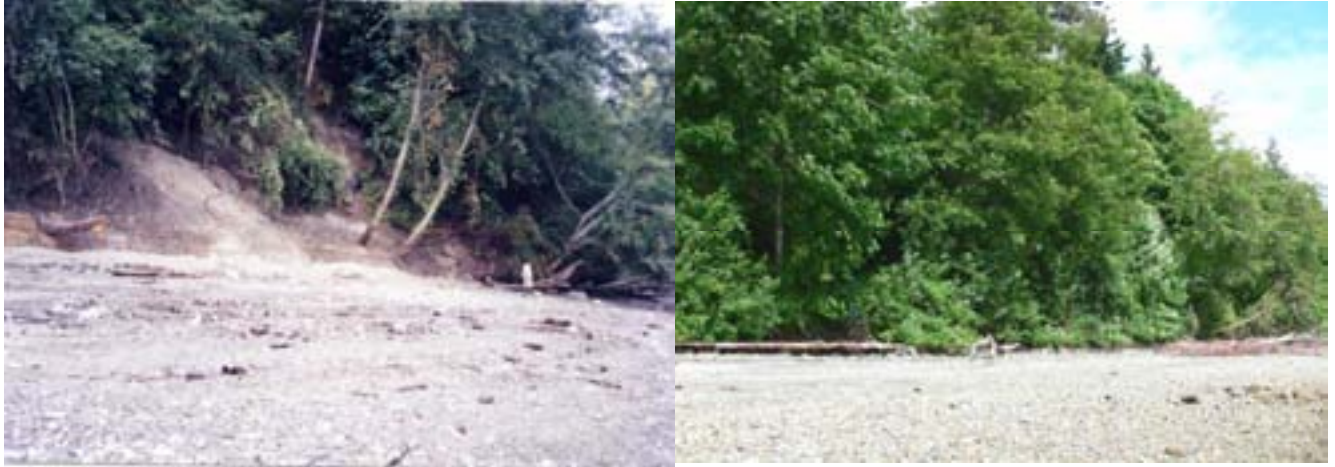
Site 1 is private property located in Kitsap County, north of Brownsville. The property faces east onto the Port Orchard canal in a med-high wave energy environment, and is classified in this study as a High Bank Stabilization project. Photo on the left shows the site during construction in August, 2000. Photo on the right shows the site during our review in June, 2006. Vegetation has established well, but less dense than on adjacent slopes. Effects of excavating the beach to bury rocks at the base of the stabilized slope are unknown.

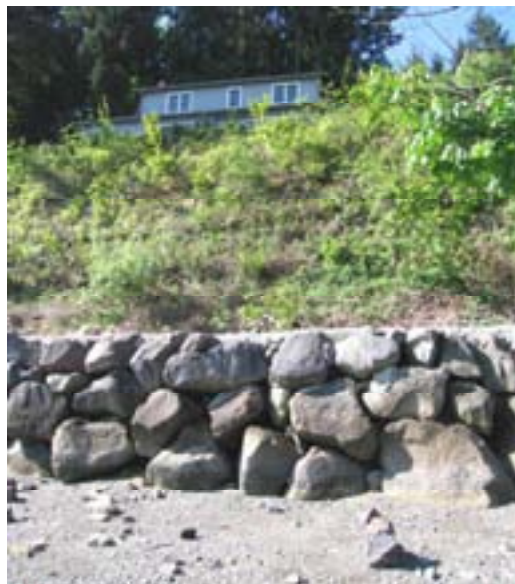
Site 2 is private property located on Butler Cove near Olympia, Thurston County. It faces north onto Budd Inlet in a low-medium wave energy environment, and is classified in this study as both a High Bank Stabilization and Bulkhead Protection or Replacement project. Photo shows the site during our review in June, 2006. The rock bulkhead, soil nailed slope, and modified vegetation make it hard to compare this site to other High-Bank alternative designs.

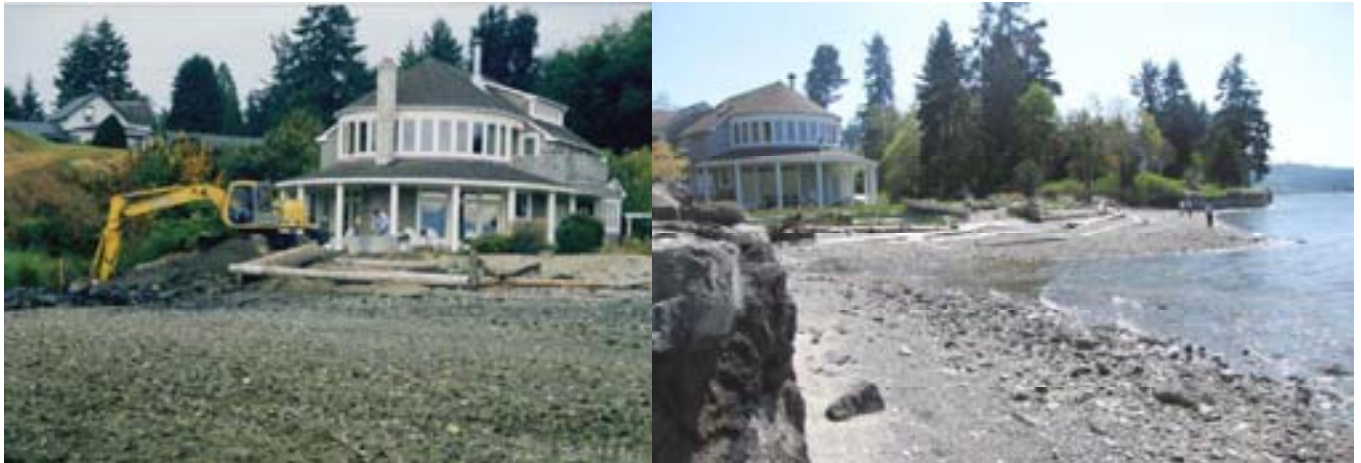
Site 3 is private property in Kitsap County, south of Lofall. It faces west onto Hood Canal in a medium wave energy environment, and is classified in this study as a Low-No Bank Stabilization project. Photo on the left shows the site during construction in 1999. Photo on the right shows the site during our review in June, 2006. This and similarly situated sites (such as 6, 7, 12, and 15) could be at increased risk from tide and storm damage with predicted sea level rise.

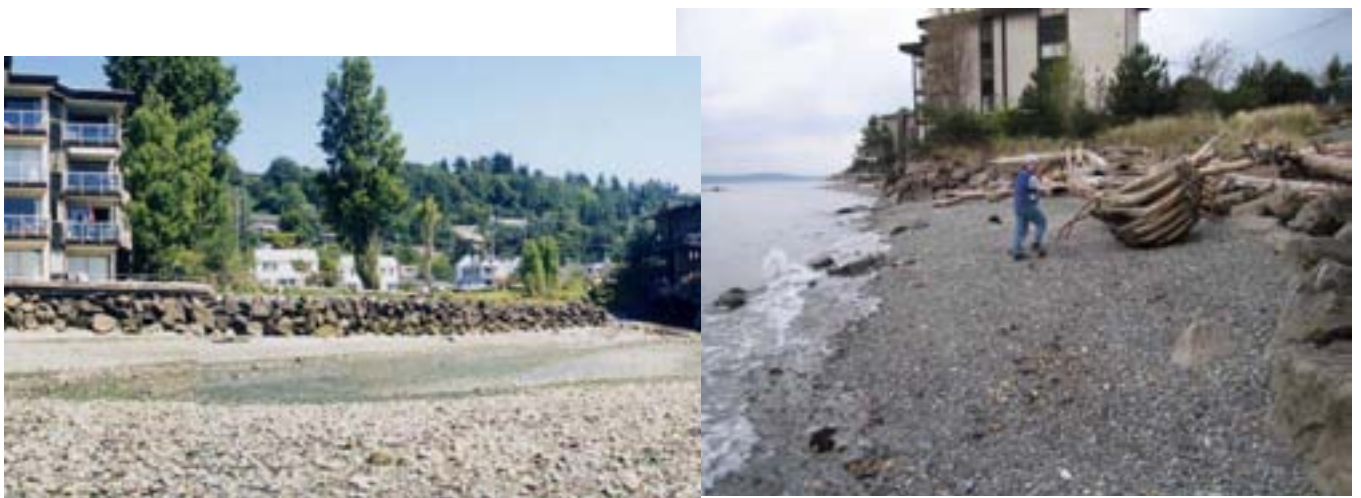
Site 4 is Cormorant Cove City Park, a neighborhood park owned by the city of Seattle and located south of Alki Point, facing west onto Puget Sound in a high energy wave environment. This site is classified as both a Low-No Bank Stabilization and a Bulkhead Removal (or relocation) project (the former because of project objectives, the latter because it involved relocating a rock bulkhead landward approximately 50-60 ft, allowing for the creation of a pocket beach). Photo on the left shows the site shortly after construction in 2000. Photo on the right shows the site during our review in June, 2006. Sediment and wood appear to have been recruited within the pocket beach, however, storm waves and surface run-off have caused erosion of beach access pathways.

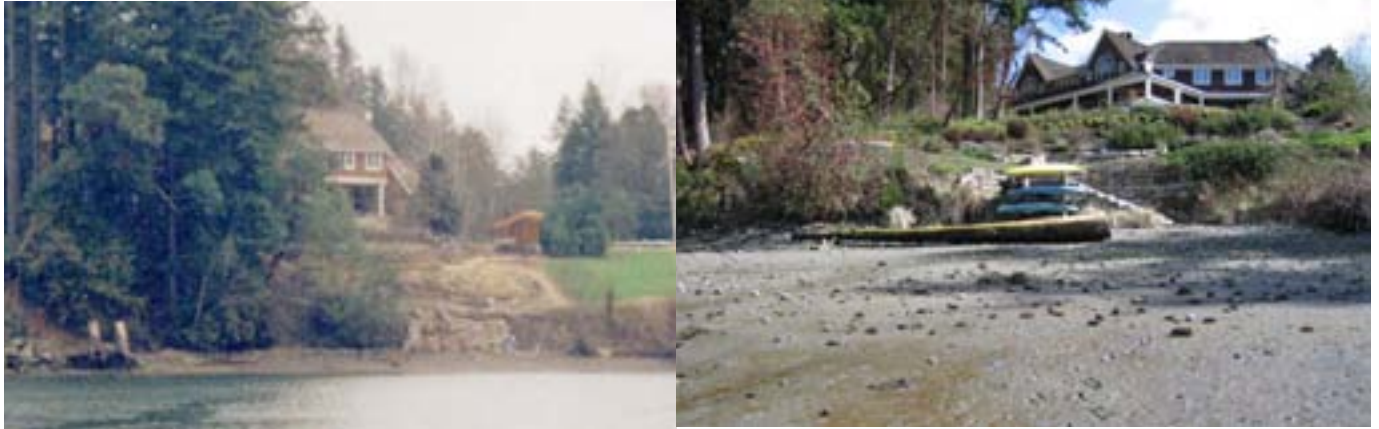
Site 5 is private property on Bainbridge Island, Kitsap Co. It faces west on an inlet of Manzanita Bay in a low wave energy environment. The site is classified as a High-Bank Stabilization project. Photo on the left shows the site shortly after construction in 1998. Photo on the right shows the site during our review in June, 2006. Logs were anchored in the beach to address a perceived problem of wave erosion at the toe of the slope. We interpreted the slope-toe cavity of concern to have been a result of sapping or piping. Additional mitigation of lining the cavity with geotextile and hand placed rock likely did more than the anchored logs to address this concern.

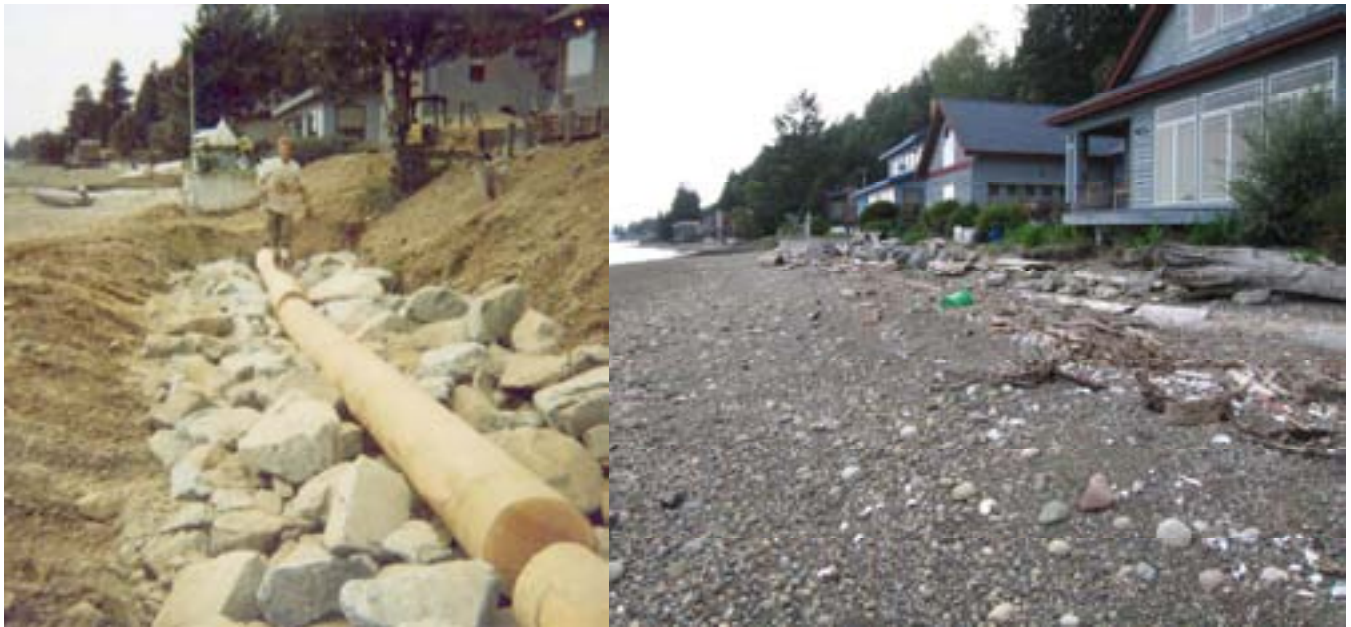
Site 6 is private property in Mason Co. a few miles southwest of Belfair. It faces south onto Hood Canal in a medium to high wave energy environment. The site is classified as a Low-No Bank Stabilization project and was constructed in 1999. Photo on the left shows the site shortly after construction in 1999. Photo on the right shows the site during our review in June, 2006. This installation held up well in the February, 2006 storm and protected the house in spite of its proximity to the storm tide inundation zone, however, it could see more wave and storm impacts to site infrastructure with predicted sea level rise. As with other similar project design applications of buried LWD anchors, effects on beach substrate and ecology of extensive excavation to bury LWD anchors is unknown.

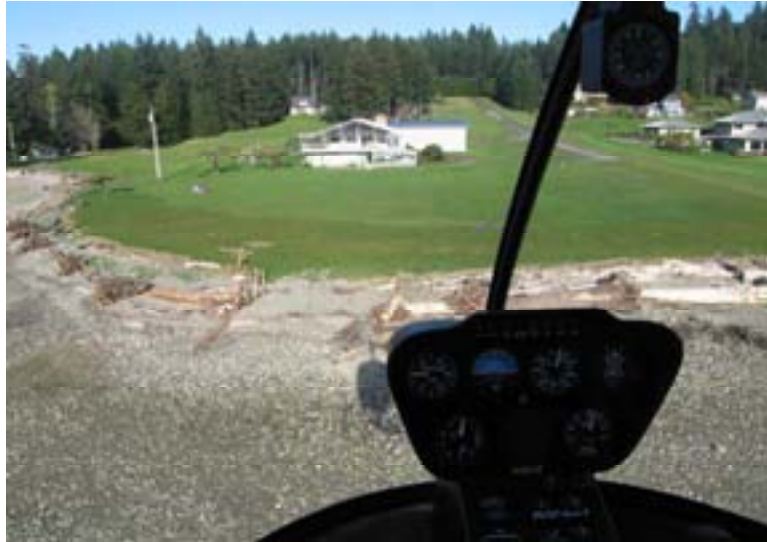
Site 7 is private property on Case Inlet in Pierce Co. It faces west onto Rocky Bay and Case Inlet in a low to medium wave energy environment. The site is classified as a Low-No Bank Stabilization project and was constructed in 2005. The photo, taken from the homeowner's helicopter, shows the site during our review in June, 2006. Past modifications to the lawn area and adjacent tide flats are a long-time consequence of shellfish harvesting activities. The homeowner and project designer is now creating a more natural looking and functioning shoreline from one strongly influenced by human activities. Another positive aspect of this site is the large set-back of the home, significantly lowering the risks associated with storms, high tides, and predicted sea level rise. Note boat ramp (just left of the helicopter dials), underlain with gravel-filled geogrid fabric.

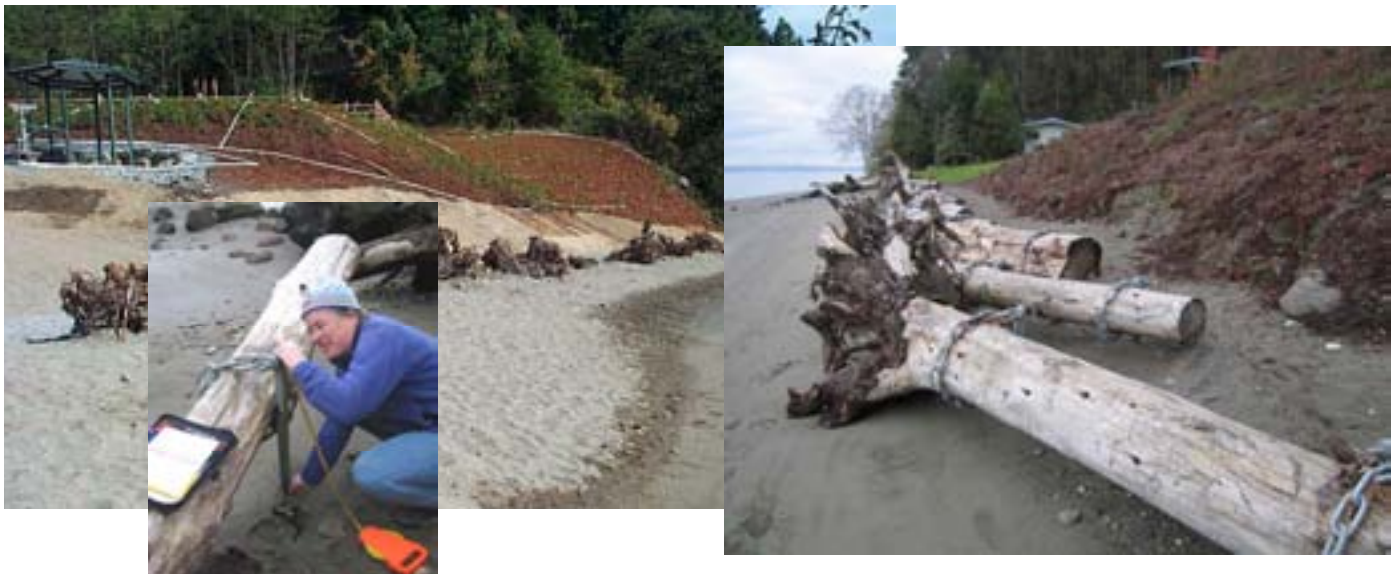
Site 8 is the Narrows County Park in Pierce Co. It is located on the west side of The Narrows waterway facing south in a medium to high wave energy environment, with a view to the northeast of the Tacoma Narrows Bridge construction. The site is classified as both a Bulkhead Removal and a Low-No Bank Stabilization project. Photo on the left shows the site shortly after construction in 2004. Photo on the right shows the site during our review in June, 2006. Small inset photo shows the monitoring conducted during our review of erosion occurring along anchored LWD. Erosion of the imported beach sand is occurring around the log anchor chains.

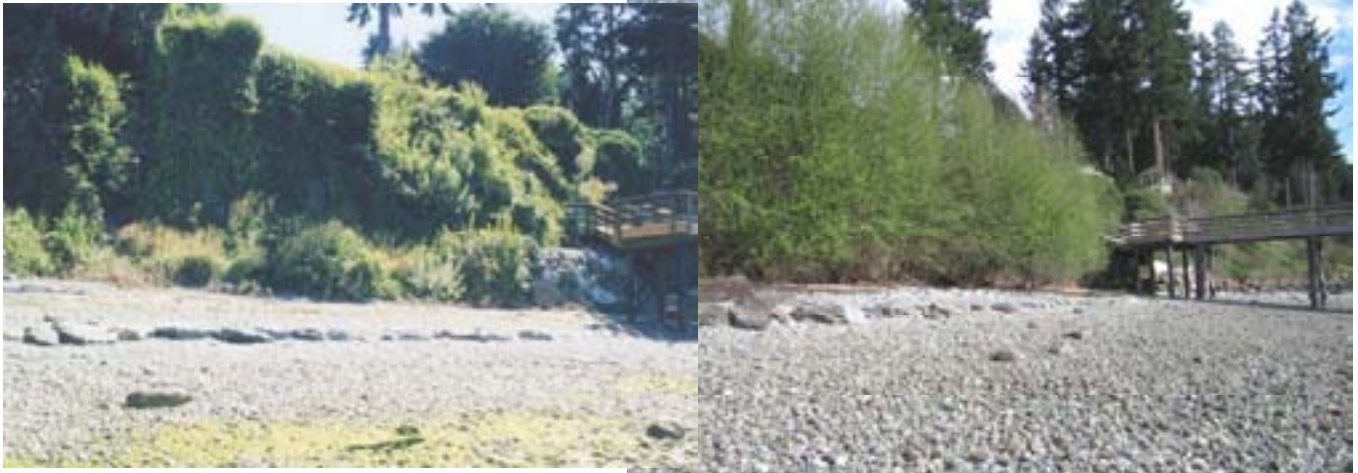
Site 9 is private property in Kitsap Co. north of Manzanita. It faces west onto Agate Passage in a medium to high wave energy environment. The site is classified as a High Bank Stabilization project. Photo on the left shows the site shortly after construction in 1998. Photo on the right shows the site during our review in June, 2006. There has been little apparent change in the processes or slope configuration of the photo-proximal portion of the project. However, erosion from the February 4, 2006 storm formed a small gully on the pathway leading to, and a cavity within in the pathway over, the rock bulkhead adjacent to the pier. The line of rocks, intended to attenuate wave energy reaching the base of the bluff might also be serving as a sill of sorts, helping maintain a relatively stable beach profile. The home at this site has a large set back and is not at risk of damage due to shoreline processes any time in the near future.

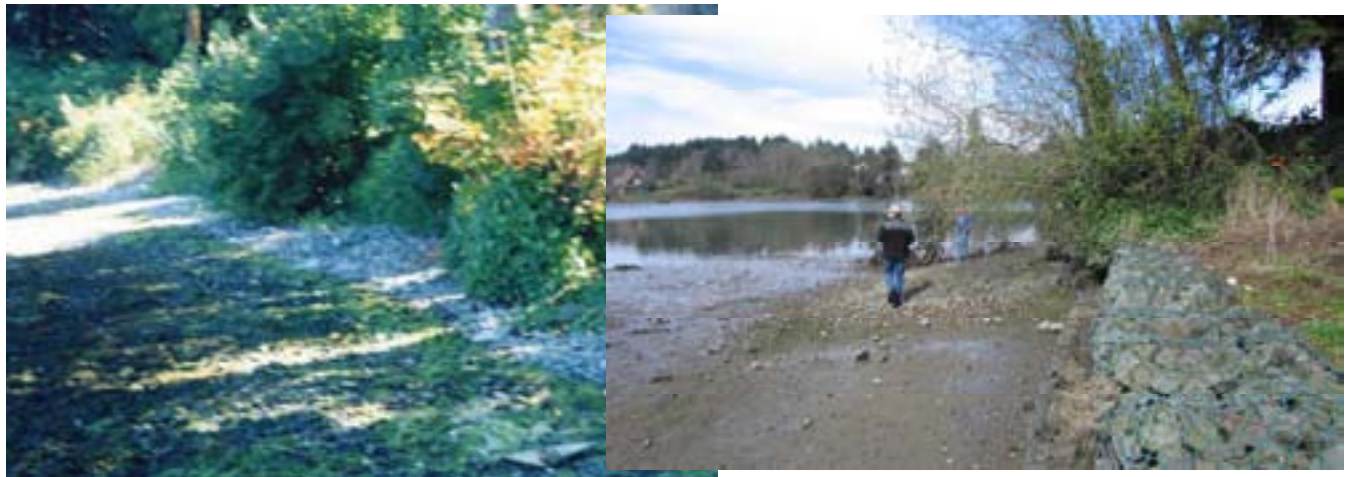
Site 10 is private property in Kitsap Co. west of Winslow on Bainbridge Island. It faces east onto Eagle Harbor in a low wave energy environment. The site is classified as a Low-No Bank Stabilization project. Photo on the left shows the site shortly after construction in 1996 (1997?). Photo on the right shows the site during our review in June, 2006. This site brings to light the need to evaluate the objectives and impacts of adding sediment that does not match that natural to the site. The added cobble gravel seen here steepens the beach and provides a different substrate habitat than along adjacent shoreline.

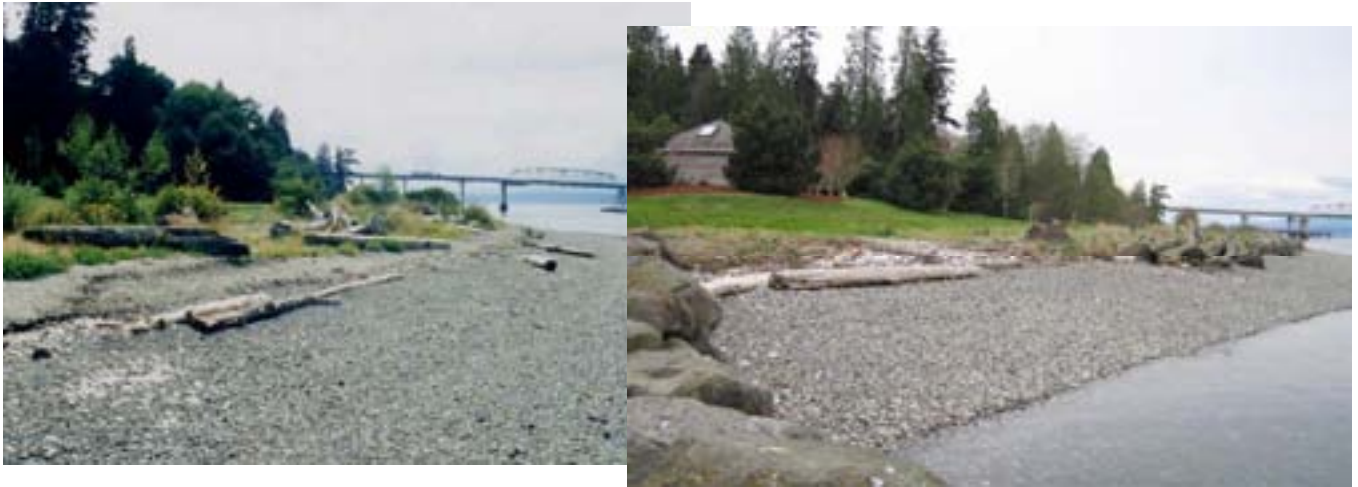
Site 11 is the Salisbury Point County Park in Kitsap Co. It faces north onto Hood Canal in a medium to high wave energy environment. The site is classified as both a Bulkhead Removal and Low-No Bank Stabilization project. Photo on the left shows the site shortly after construction in 1995. Photo on the right shows the site during our review in June, 2006. Bulkhead removal at this site had the positive effects of improving beach access, increasing beach width, and recruiting LWD, without incurring much risk to expensive upland infrastructure.

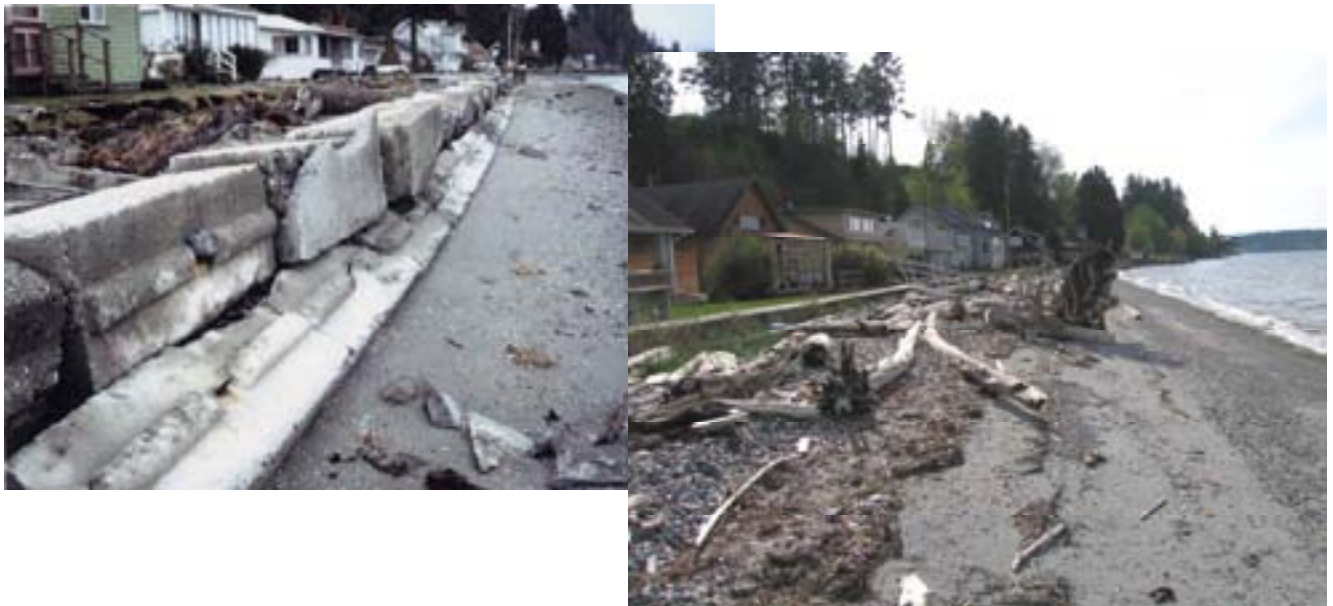
Site 12 consists of 16 adjoining private properties in Skagit Co. All face north onto Samish Bay in a high wave energy environment. The site is classified as a Bulkhead Protection project. Photo on the left shows the site shortly after construction in 1998. Photo on the right shows the site during our review in June, 2006. The sill at the down-drift end of the participating properties (behind the photographer) has preserved the added beach sediment and beach profile, reduced erosion of existing bulkheads, reduced the risks to waterfront homes, and helped to recruit LWD. Home-owners are very happy with the results. The adjacent beach down drift to the east (not shown in these photos) appears to be migrating landward.

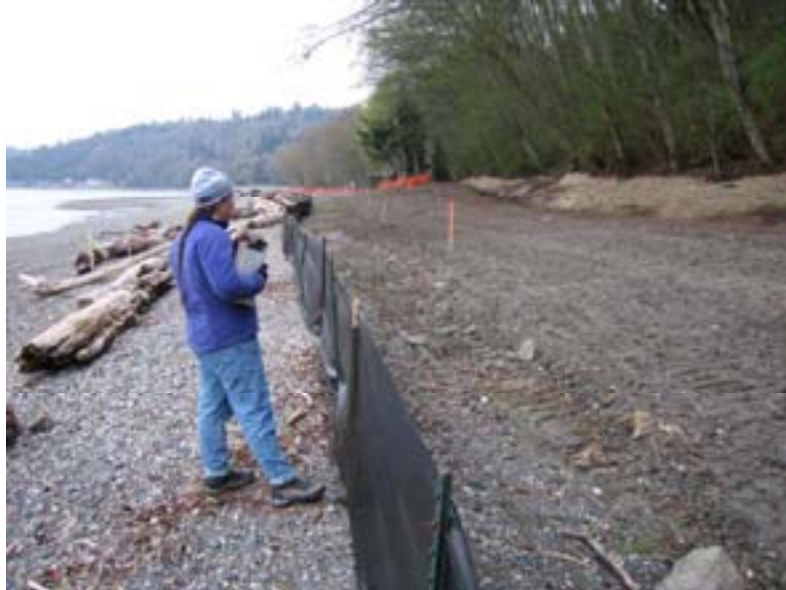
Site 13 the Seahurst County Park in Burien, King Co. It faces west onto Puget Sound in a moderate to high wave energy environment. The site is classified as a Bulkhead Removal, High Bank, and Low-No Bank Stabilization project. Photo shows the site during its construction and our review in June, 2006. This site has had a healthy riparian zone, but it was somewhat separated from the beach by the bulkhead. With the bulkhead removal and regrading of the lower slope, it should be more effective at contributing LWD to the beach. The city of Burien is investigating removal of additional seawall and bulkheading to the north of the shoreline reach pictured here.

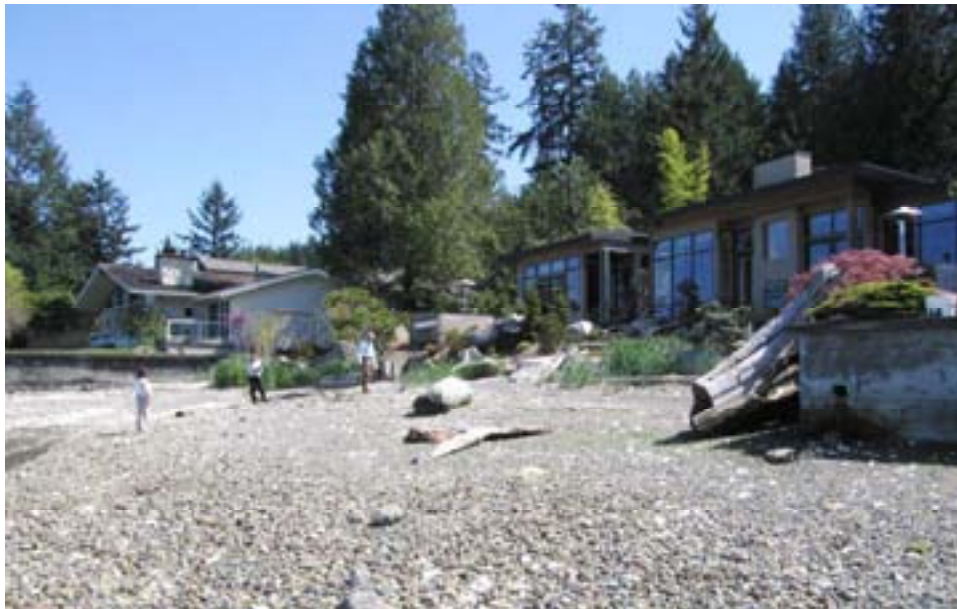
Site 14 is private property in Kitsap Co. near Seabeck. It faces north onto Hood Canal in a moderate to high wave energy environment. The site is classified as a Bulkhead Removal project. Photo shows the site during our review in June, 2006. This site illustrates the potential for successfully creating a pocket beach within a reach dominated by concrete bulkheads, and the possibility of restoring some beach habitat, even if not necessarily an adjacent riparian zone.

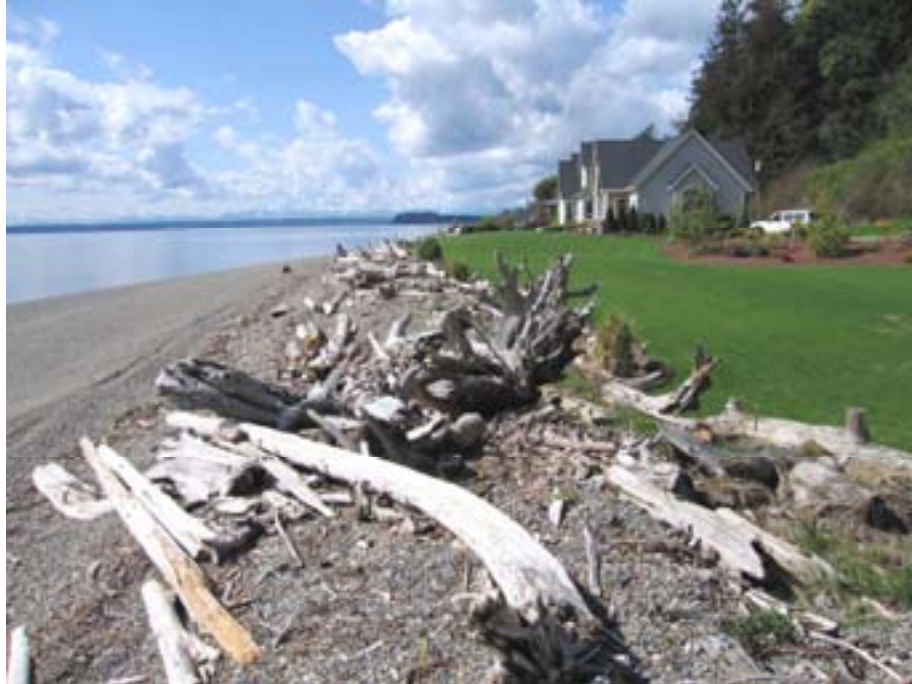
Site 15 is private property on Fox Island in Pierce Co. It faces southwest onto Carr Inlet in a moderate to high wave energy environment. The site is classified as a Low-No Bank Stabilization project. Construction date is uncertain. The photo shows the site during our review in June, 2006. We observed evidence of periodic overtopping of the berm onto the lawn by storm waves. The site is located on a filled backshore at the base of a steep slope prone to landsliding.

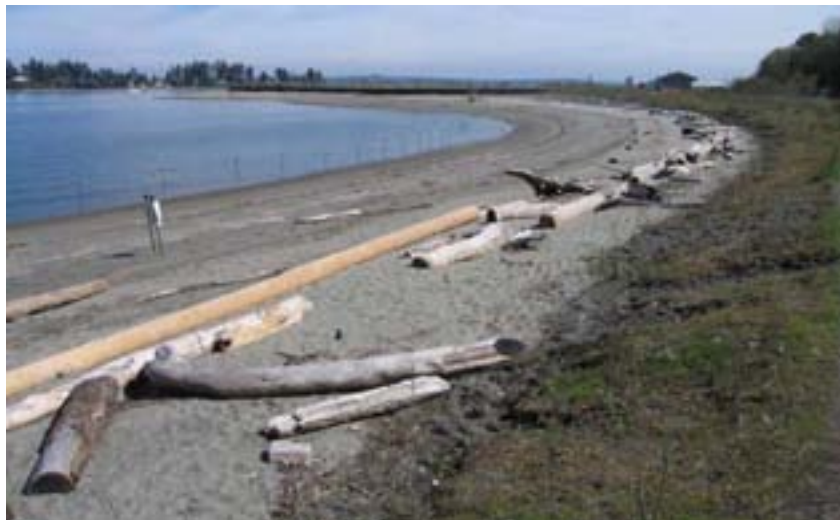
Site 16 is an EPA Superfund Site currently undergoing clean-up. It is located on Bainbridge Island, Kitsap Co., south of Winslow. It faces north onto Eagle Harbor in a relatively low wave energy environment, although it is exposed to ferry boat waves. The site is classified as a Bulkhead Removal project, with the initial removal of the log pile bulkhead occurring in 2001. Photo shows the site during our review in June, 2006. Some erosion of the berm in the foreground has occurred, but otherwise the beach appears to be relatively stable and recreational use of the site is apparently common.

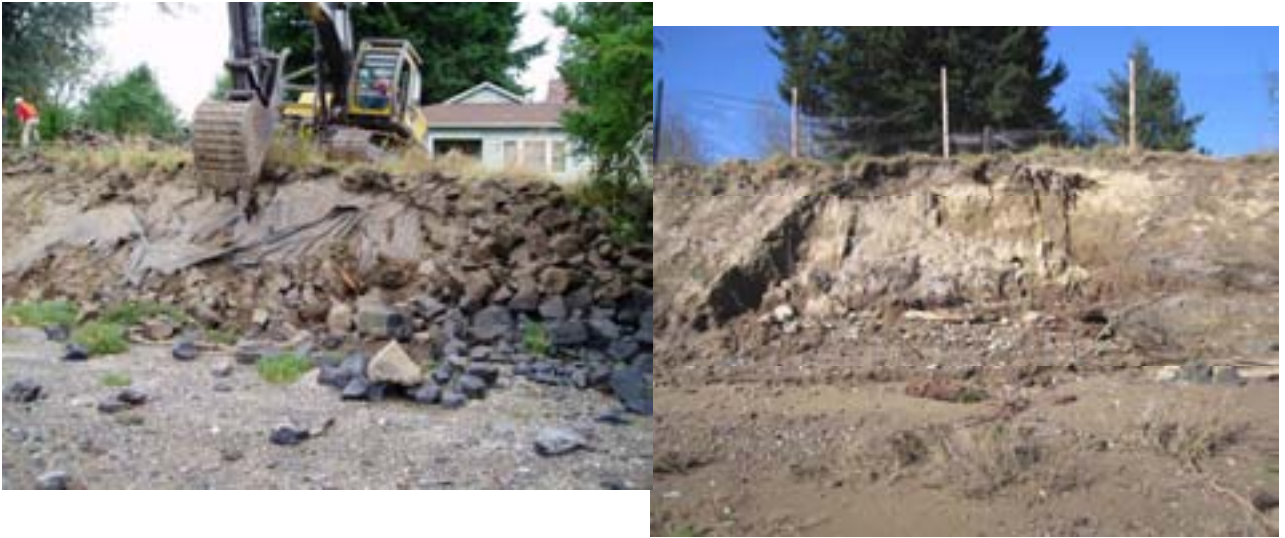
Site 17 is a State-owned Natural Resources Conservation Area in Thurston Co. Being located on a small peninsula in Henderson Inlet, it has shoreline exposure to the north, east, and south in a low to medium wave energy environment. The site is classified as a Bulkhead Removal project. It was completed in 2005. Photo on the left shows the site during deconstruction in 2005. Photo on the right shows the site in March, 2006, shortly after the high-tide storm event of February 4th, 2006. Landslides of this type can be expected on recently-exposed unvegetated slopes, over-steepened following bulkhead removal. Slope retreat is an expected consequence in the short term, but rates of retreat should slow in the long term, under current climatic/sea level conditions.
